Stonbury carried out refurbishments to several constructed wetlands on a Water Recycling Centre (WRC).

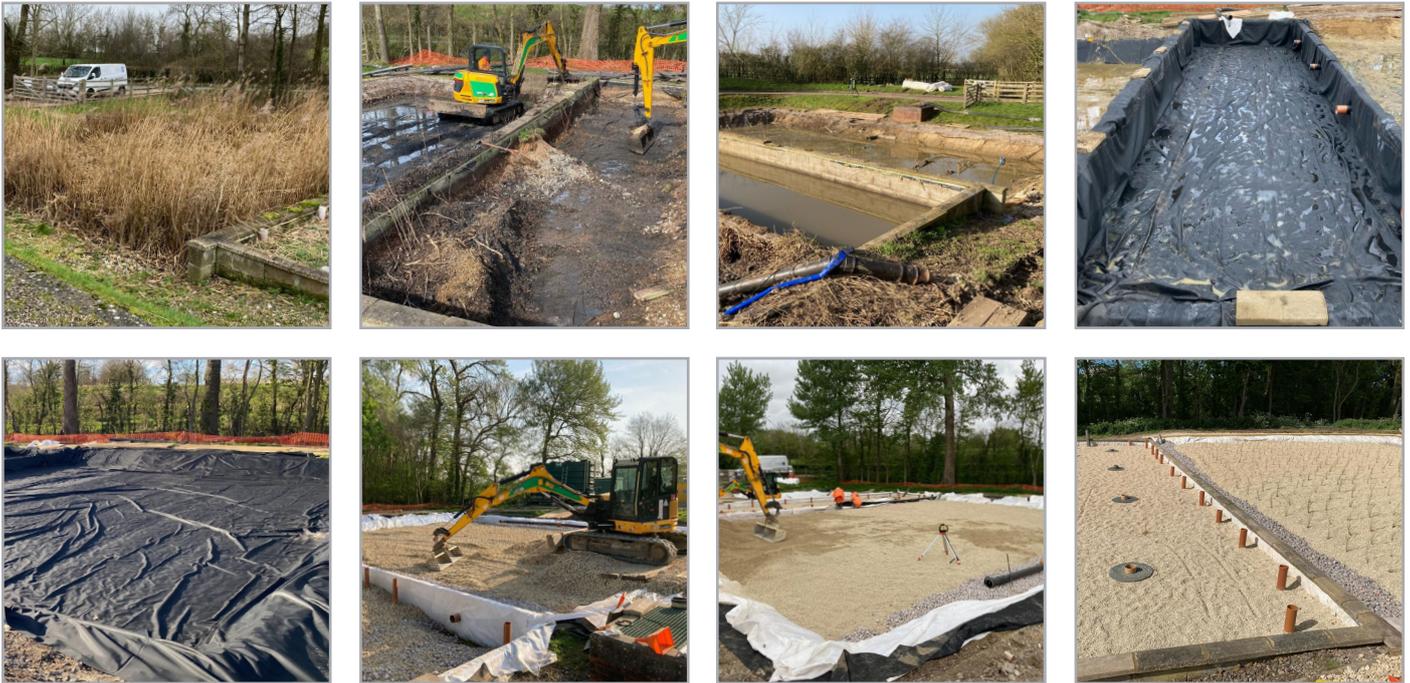
The site consisted of three beds which treat effluent from adjacent properties prior to discharge into the watercourse. The existing 600 metre-squared system was overgrown and partially blinded with sediment which was preventing effluent from effectively filtering through the system. This became apparent via sub-optimal sampling data.

Before commencing work, Stonbury conducted trial digs to assess the condition of the liner. Several damaged areas were identified; these were caused by self-sown trees and tears from fallen coping stones. Due to its age and degree of damage it was not practical to repair it so the client agreed to replace the liner.

The existing liner and geotextile were then removed and the clay base was re-compacted to receive the new linings. A new base geotextile layer was rolled out, ensuring suitable overlap between adjacent strips. The EPDM liner was then laid using the excavator equipped with a spreader bar. The liner was manipulated to ensure that it was flat and provided sufficient material to terminate against the concrete structures and into the anchor trench. Inlet and outlet pipe penetrations were welded and sealed.

The lagoon was water tested for an agreed period of five days. Following a successful test, the water was removed from the lagoon and an additional protective layer of geotextile was placed on the liner prior to reinstalling the filter media. Replacement stone media of graduated sizes was laid in appropriate layers and levelled. Aeration pipes and inlet/outlet pipework was installed at this point.

Finally, approximately three and half thousand *Phragmites australis* reeds were planted by hand at a rate of six to eight per metre squared, successfully returning the beds to design condition.
