PROJECT NEWS

PROJECT REPAIR TO FLOOD BANK SLIPPAGE

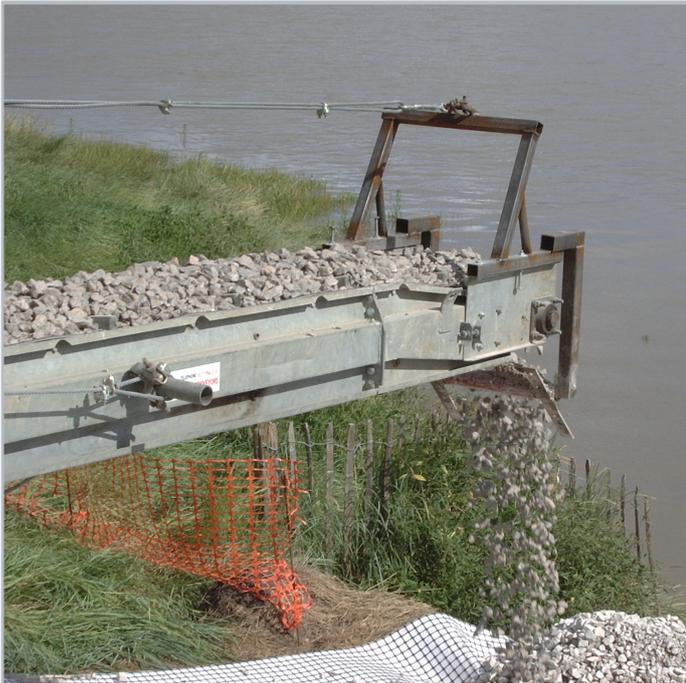
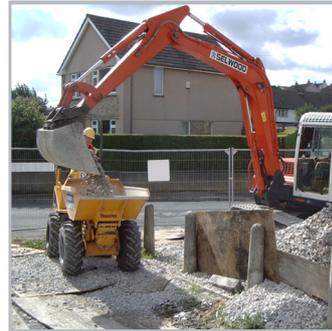
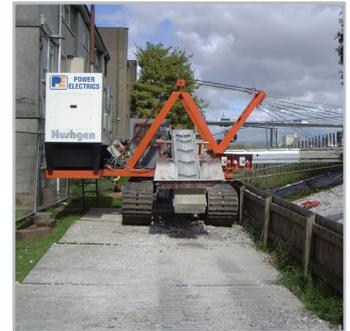
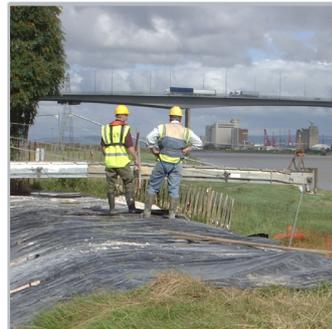
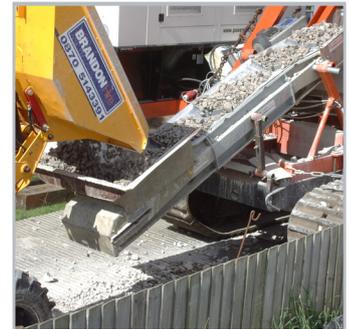
Kingcombe Aquacare was called in by the Environment Agency to solve a challenging problem. The mud flood bank of the River Avon at Pill had slipped, threatening the integrity of the residential flats that were situated alongside this stretch of the tidal reach. The void had to be infilled with stone on a geotextile base, to re-establish the integrity of the bank, however access to the site was proved to be quite a challenge.

It was considered not possible to address the problem from the river, due to the major fluctuations in tidal levels and maintaining a barge in situ in the significant flows. However, it was equally difficult to access the problem area from the bank. There was insufficient space between the residential property and the flood bank for an excavator with sufficient reach to get close enough to the void area.

This challenge was exacerbated by the fact that a high pressure gas mains ran under the length of track running between the properties and the river, limiting the weight of any machine that could be used.

Kingcombe designed a novel and bespoke solution to address these challenges in a safe and cost effective manner.

A special frame was fabricated to fit onto one of our 3 tonne tracked dumpers. This was fitted with a 20m conveyor system hanging over one side, counterbalanced by the generator pack mounted on the dumper. A hopper system was designed to receive the stone from a 2 tonne dumper, which was able to run back and forth along the track without compromising the gas main underneath the path.
