A final settlement lagoon required repair and refurbishment work due to wildlife damage and bank slippage, which had caused the lagoon to leak.

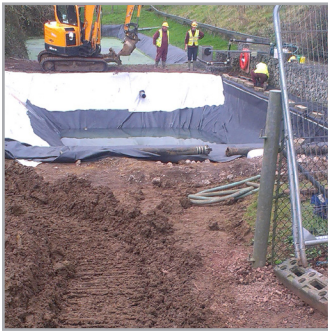
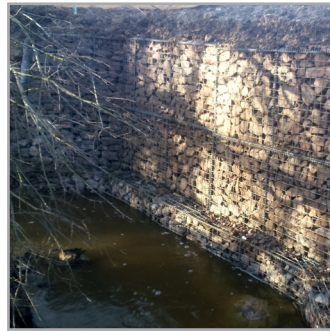
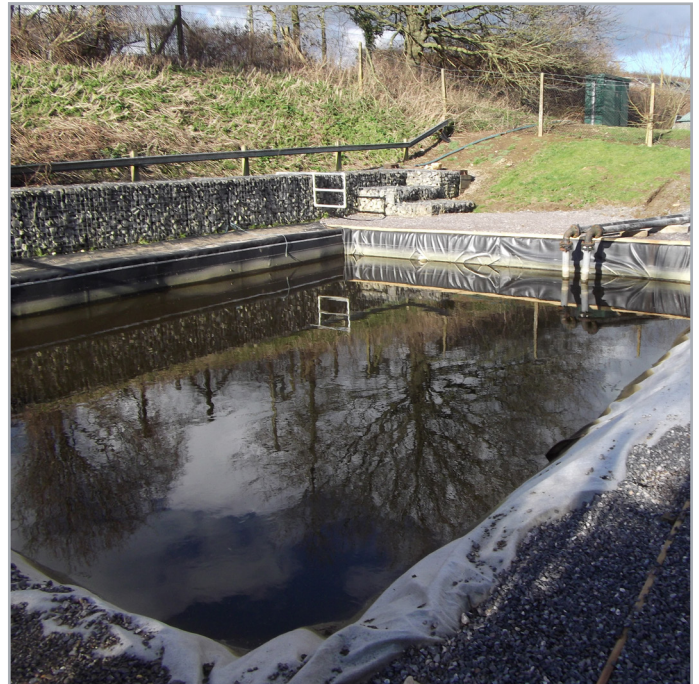
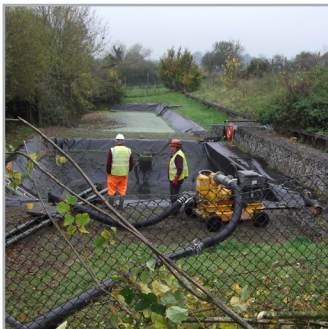
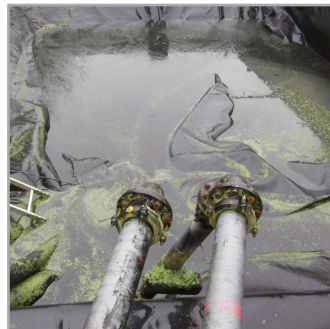
Once the existing liner had been removed, it was clear that the existing vertical gabion walls had started to fail due to immersion and consequent corrosion.

The scope included relining one of the final settlement lagoons and the installation of a new gabion wall to support the bank and existing lagoons above, and to avoid any further erosion and bank slippage.

The gabions were repaired, and the faces of the gabions were lined with recycled plastic boards before installing the new EPDM liner.

An under-liner drainage system was also established, and a new chain link fence and access path was installed for safe access to operatives in the future.
