PROJECT RESERVOIR ROOF REPLACEMENT

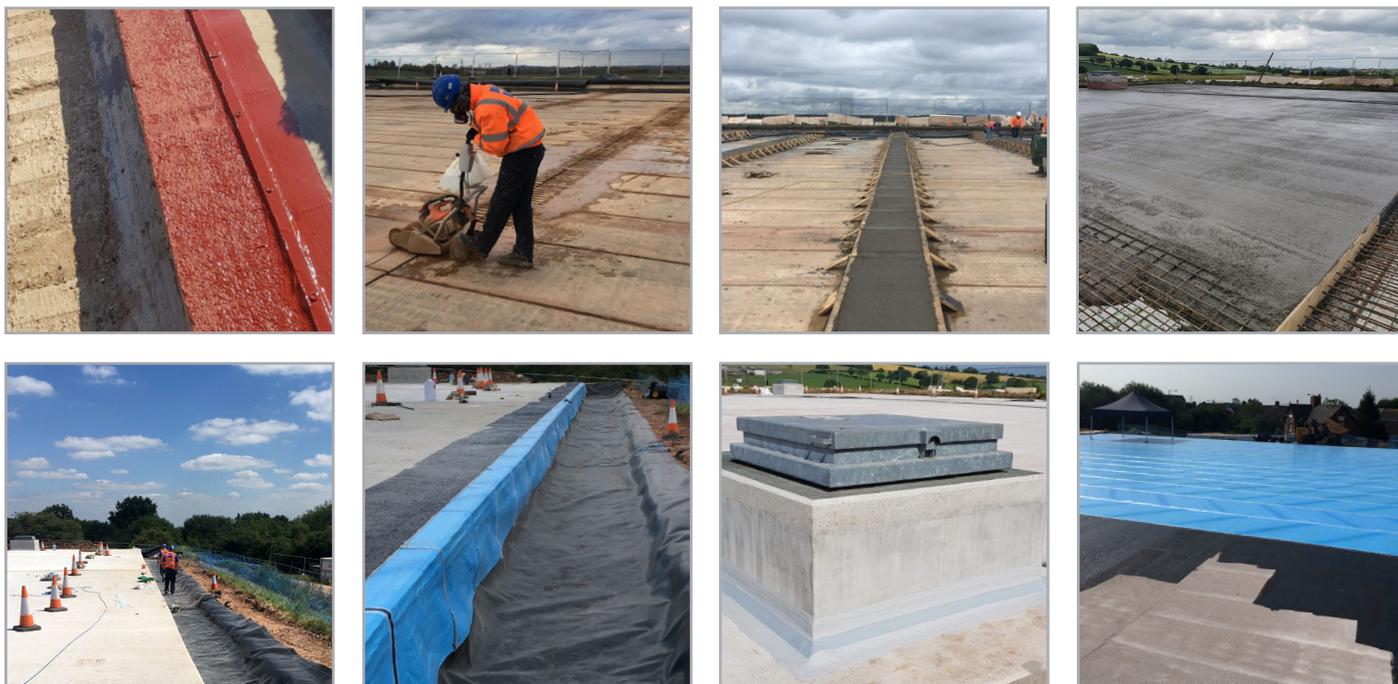
Stonbury were recently contracted to install a bonded membrane system to a service reservoir roof. However, following further investigation, it was clear that with the configuration of the existing structure, this would not be possible.

The reservoir was made up of two cells, following an extension to the west and north side of the original tank. The walls were cast in situ concrete, which required the passive restraint from the surrounding earth embankment to ensure structural stability, and the roof was finished with precast hollow core concrete planks and a loose lay membrane. This design did not meet the current standard set by the client.

Following a 3D scan of the reservoir, it was decided that a new roof slab would be the best solution, and a scope of works was put into place. During the works, the live cell needed to remain watertight at all times, this was achieved with the use of temporary batten strips, mastic and liquid membrane seals. The joints were regularly inspected and maintained throughout the scheme.

Works began with the removal of the existing overburden, the loose lay membrane and the profiled polystyrene insulation boards. This included hand digging to safely expose the telemetry cables. The roof joints were then filled, the existing membrane on the live side was sealed down and the roof was cleaned in preparation for the new screed.

To form a solid structural foundation, sections of the existing slab were cut into, and the voids were infilled with concrete. This created the base for the support pads, which would support the weight of the new roof. A lightweight screed was then pumped between the pads to profile the roof to a 1 in 100 fall. Once cured, collapsible fill was used to level the surface and protect against the potential effects of ground heave.

Repairs were completed on all of the upstands, including rendering and fillets. However, two of the upstands were in deplorable condition and required breaking out. Overbanding was applied to the remaining upstands, followed by a waterproof liquid membrane. The redundant drainage and pipes were also removed and replaced with a new impermeable drain and new drainage chambers.

Steelwork was lifted onto the roof and tied into place, once secure, concrete was pumped onto the roof in sections and left to cure. To ensure a tight seal between the old and new roof slabs, the void was filled with polystyrene and made watertight using bonded membrane.

To complete the roof, a bitumen primer was applied, followed by a bonded membrane system, which successfully passed a spark test. Following the completion of a flood test, geotextile fleece will be laid, and the overburden will be reinstated.
