Stonbury were contracted to carry out comprehensive restoration works to a failing river bank that had become very unstable due to a water main leak.

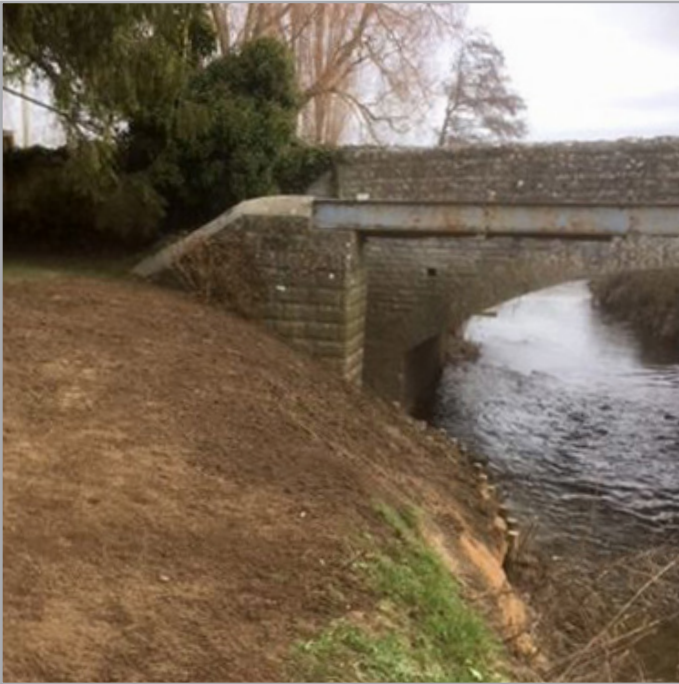
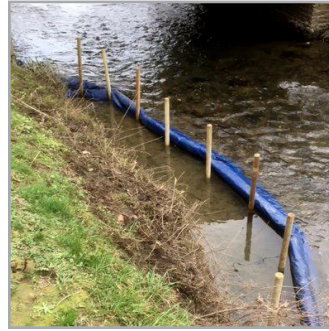
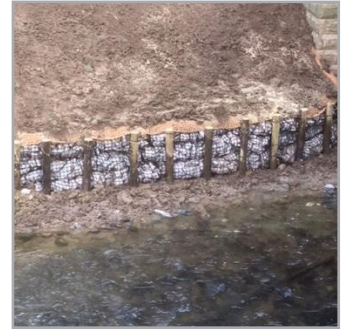
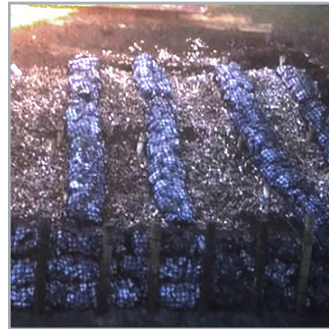
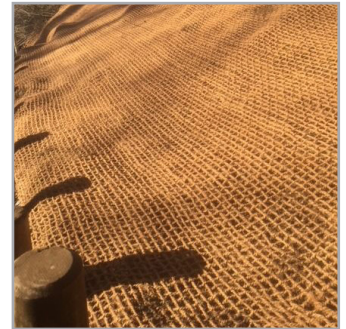
A CAT scan of the area was conducted prior to the excavation of a 3m trench and the installation of support stakes along the river and bankside. Rock rolls were then laid horizontally and securely tied to each other and the hardwood stakes, ensuring a sufficient hold.

Drainage shelves and trenches were dug into the bank and filled with stone to create a constant gradient that will allow the bank to drain during a flood event and protect the surrounding areas.

Once fully installed, soil was layered over the rock rolls followed by a coir roll matting to provide further stabilisation to the bank and prevent future soil erosion.

A final layer of top soil was used to cover the matting and grass seed was distributed across the bank and surround areas.
