**PROJECT** WASTEWATER OUTFALL REPAIRS

Stonbury was contracted to carry out concrete repairs to several joints along a wastewater outfall located on the North Sea. In addition, the scope included the installation of new foundation pads and a riprap wave protection barrier.

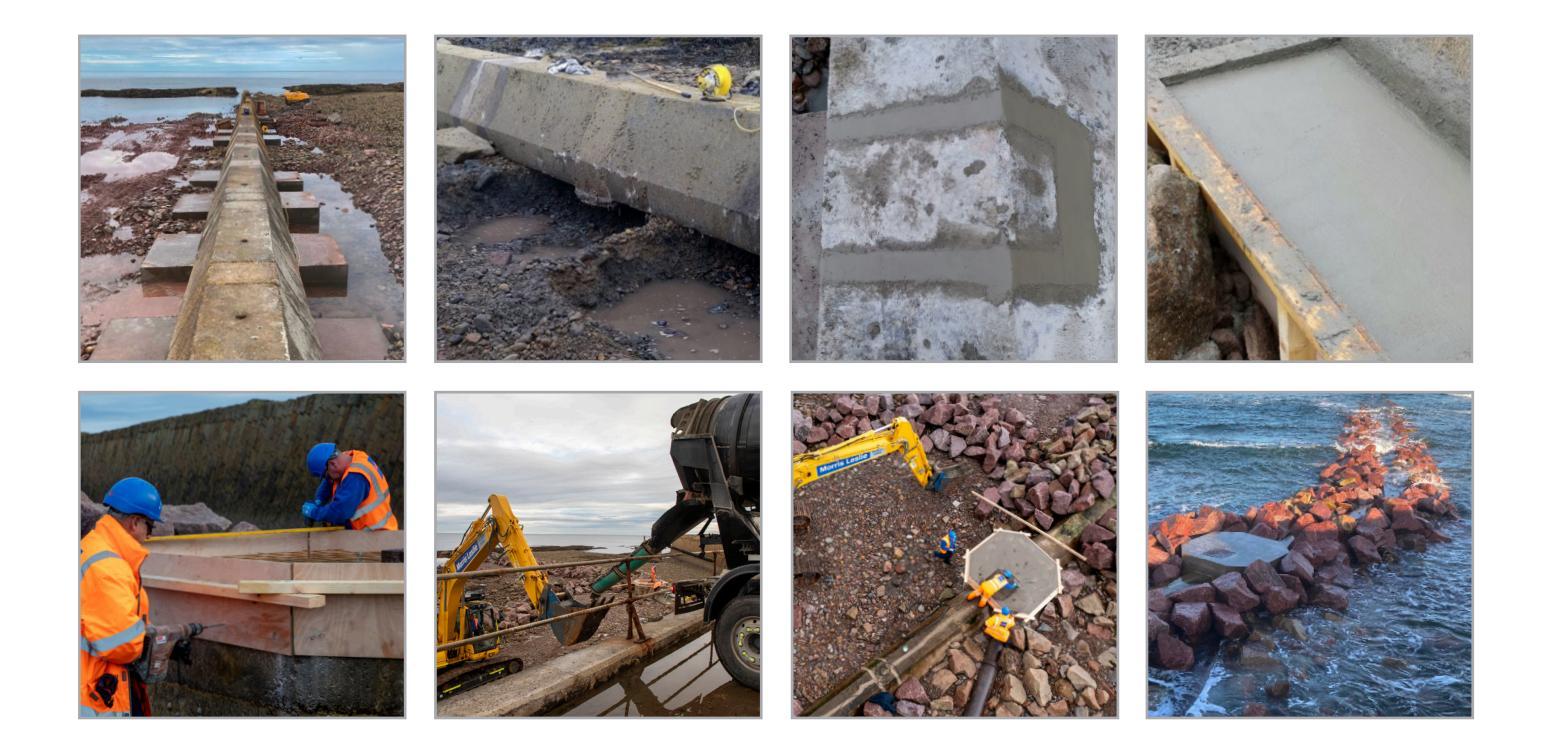
Working around favourable tide times and good weather, the site team used an environmentally friendly mortar, resistant to salt attack, for the joint repairs and a highstrength concrete with an additive to speed up the cure. Both products were chosen for their rapid cure properties, minimising the risk of damage from the daily tides. The team excavated around the outfall. Shuttering was then used to install and pour sixteen new foundation pads, providing sufficient support for the structure and preventing potential collapse in the future.

Following the completion of the foundation pads, the team continued to carry out any remaining joint repairs and began work on the maintenance hole. Shuttering and steel reinforcement was installed in preparation for a concrete pour to cap the existing utility hole ring. Once all concrete repairs were complete, the immediate area around the outfall was reinstated. With the use of an excavator, 1400 tonnes of rock armour was transported along the beach and placed down both sides and across the top of the outfall structure to protect the concrete from future erosion caused by high tides and storm events.
